Manhole Inspection Summary

Manhole # S31S1_014MH

Location Address: **3423 Round Rd.**

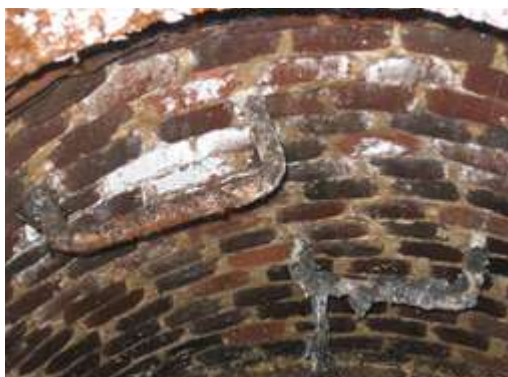
Steps Count: **2** Missing: **0** ☐ Corroded

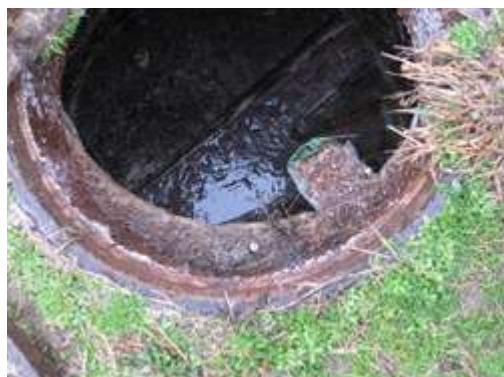
Defect 1

Frame Offset: **4** (in.) Condition: ☒ Sound ☐ Cracked ☐ Leaks

Frame offset

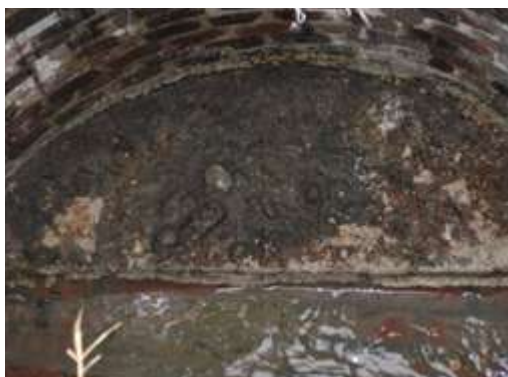
Defect 2

Condition: ☒ Sound ☐ Cracked ☐ Root Intrusion ☐ Deteriorated ☐ Leaks ☐ Debris

Bench

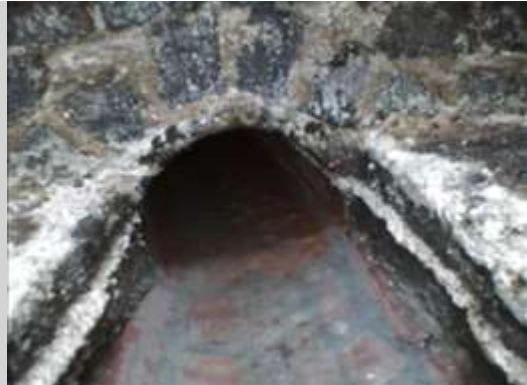
12 O'Clock Outflow

8 in. Circular Gravity Sewer
Pipe Out @ 12 O'Clock

Pipe Height: **12** (in.) Rod and Bar (Angled)
Pipe Material: **Clay** ☐ Pipe Lined
Invert Depth: **6.23** (ft.) Flow Characteristics: **Fast**
Deposits: ☒ None ☐ Mud ☐ Sludge ☐ Debris ☐ Grease
Silt Depth: (in.) Deposits Extent:
Infiltration: **None** Pipe Seal Cond: **Sound**

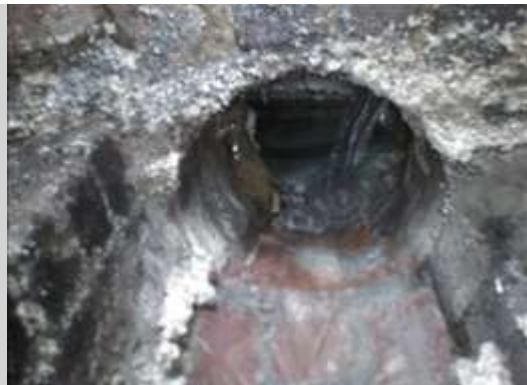
5 O'Clock Inflow

8 in. Circular Gravity Sewer
Pipe In @ 5 O'Clock

Pipe Height: **9.6** (in.) Rod and Bar (Angled)
Pipe Material: **Clay** ☐ Pipe Lined
Invert Depth: **5.96** (ft.) Flow Characteristics: **Fast**
Deposits: ☒ None ☐ Mud ☐ Sludge ☐ Debris ☐ Grease
Silt Depth: (in.) Deposits Extent:
Infiltration: **None** Pipe Seal Cond: **Sound**

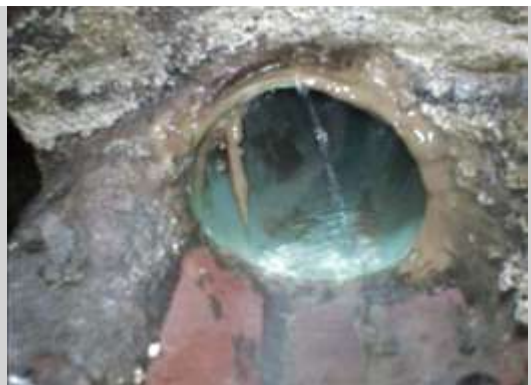
7 O'Clock Inflow

6 in. Circular Service Sewer
Pipe In @ 7 O'Clock

Pipe Height: **7.2** (in.) Rod and Bar (Angled)

Pipe Material: **PVC** ☐ Pipe Lined

Invert Depth: **5.91** (ft.) Flow Characteristics: **Fast**

Infiltration: **None**

Pipe Seal Cond: **Sound**
